## 1 Health Report Summary

# Diagnosis Report

Vehicle Info: 2009\Pontiac\VIBE AWD A/T\0) 2.4L L4 LAX

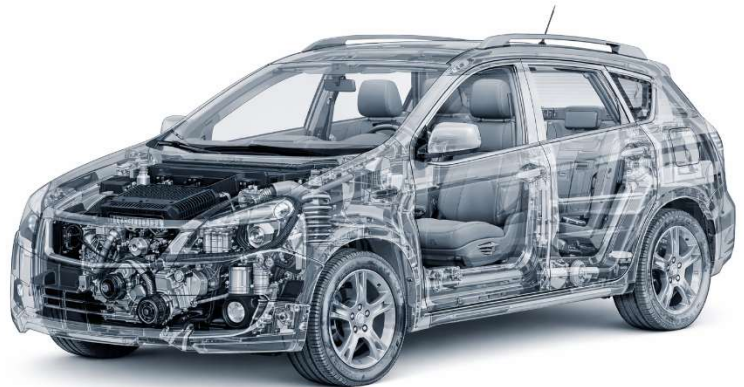
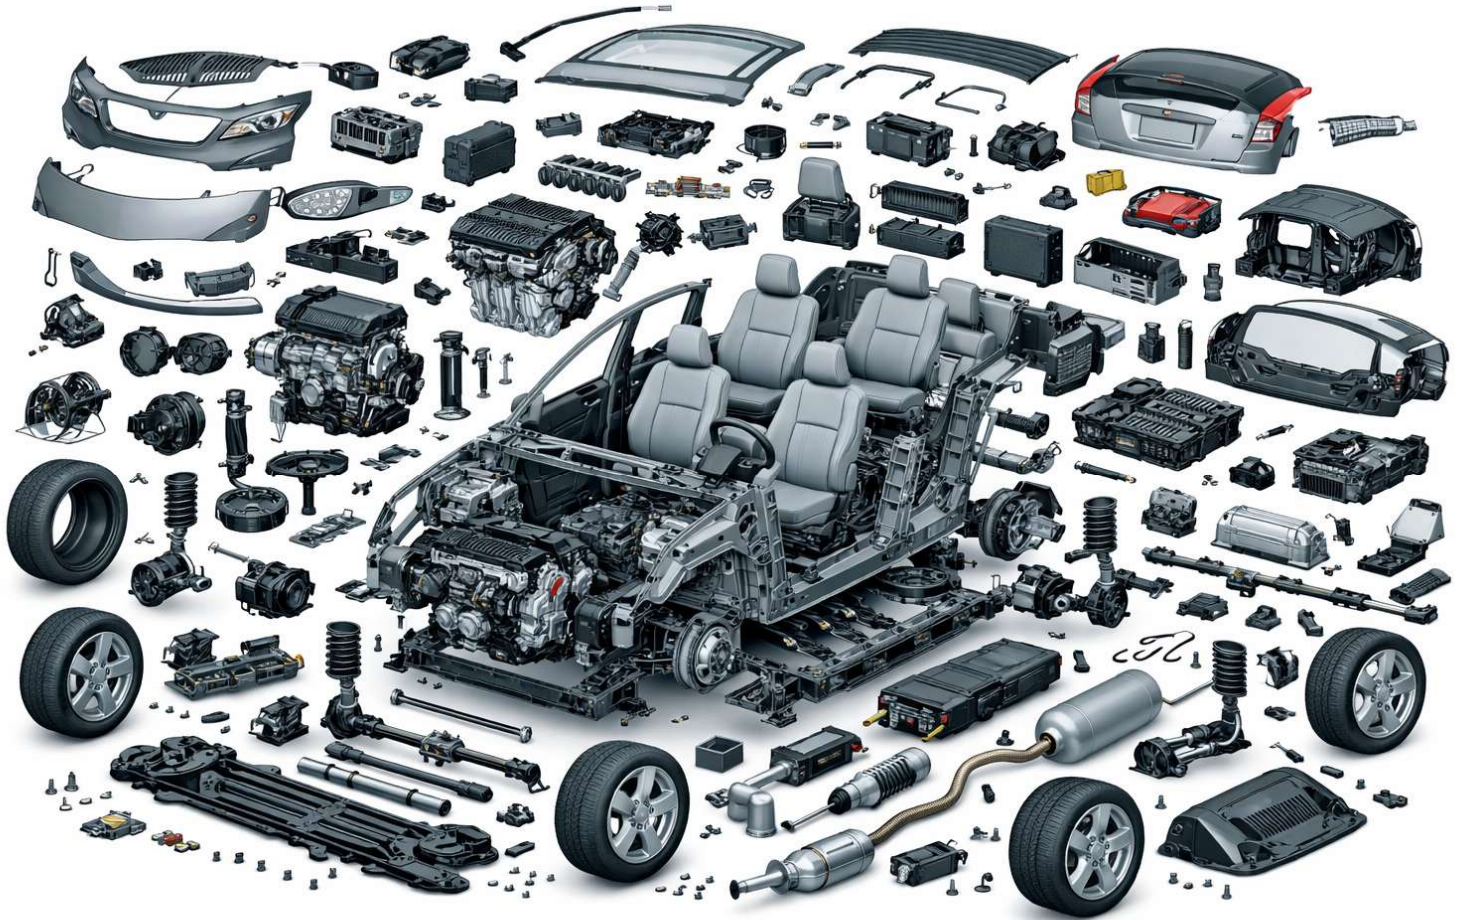
**Summary of Findings:** Your vehicle was inspected due to an oil pressure warning and abnormal engine noise. A mechanical oil pressure gauge was connected directly to the engine's oil gallery. The gauge showed **0 PSI**, confirming that the engine is not receiving the oil pressure it needs to operate safely.

During the electronic diagnostic scan, the engine computer reported a **P0012 – Intake Camshaft Position System Retarded**. This code appears when the engine's variable valve timing system cannot function due to **insufficient oil pressure**. The engine also produced noise under acceleration, which is consistent with internal components not receiving proper lubrication.

**What This Means:** The engine is experiencing **real low oil pressure**, not a sensor or electrical issue. This condition can cause internal engine damage if continued to operate. The most common causes are a **failed pickup tube O-ring**, a **clogged oil pickup screen**, or a **fault in the oil pump assembly**.

Based on the test results, the next step is to **inspect the oil pickup system and pump assembly**. This requires removing the oil pan and lower engine components to access the pickup tube, O-ring, and pump.

- Remove oil pan
- Inspect pickup tube and O-ring
- Inspect pickup screen for blockage
- Inspect oil pump and relief valve
- Check for bearing wear or metal contamination
- Verify timing chain tensioner oil feed
